# CASCADE PROPERTY INSPECTION

## SUMMARY REPORT

**Client:** Joe Oregon  
**Realtor:** Joe Duncan, Willamette Valley Real Estate  
**Inspection Address:** 222 Willamette Valley, , OR  
**Inspection Date:** 9/26/2015  
**Inspected by:** David Gray

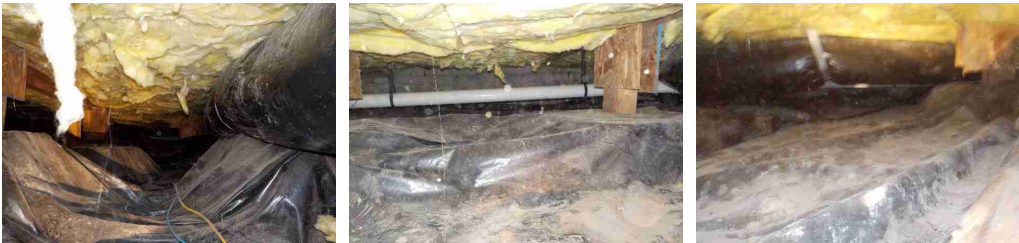
The crawlspace is accessible and in acceptable condition.

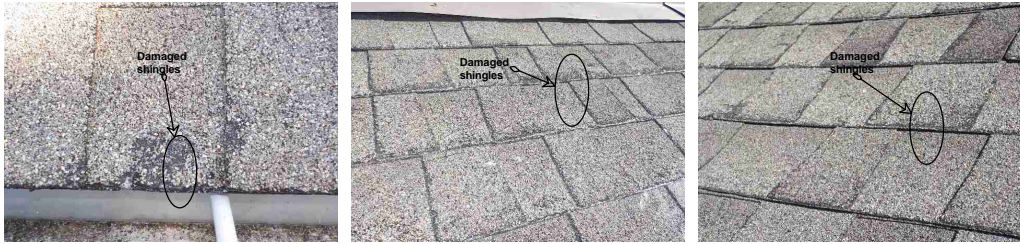
There are damaged roofing shingles in the front of the house that should be evaluated by a licensed roofing contractor.

There is damaged roofing shingles in the front - *Continued*

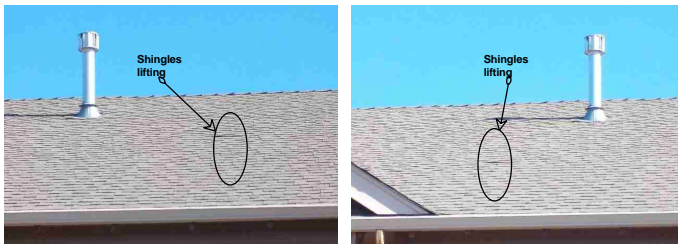
There are shingles that are lifting and are not sealed.  
Recommend these shingles be evaluated by a licensed roofer.

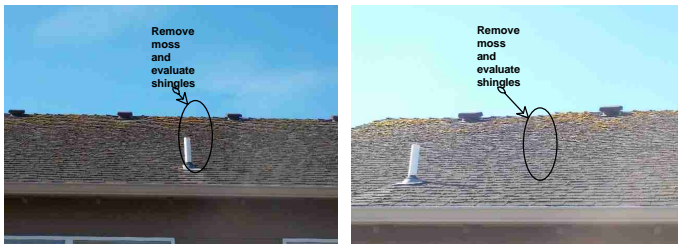
There is a large amount of moss on the roof on the back side of the house.  
I recommend removing the moss and a licensed roofing contractor evaluate the shingles as they could be damaged or leak.

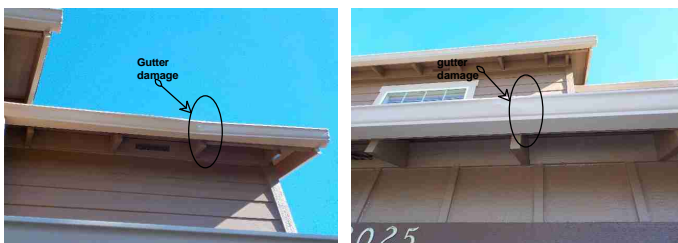
There are damaged gutters that should be evaluated for replacement.

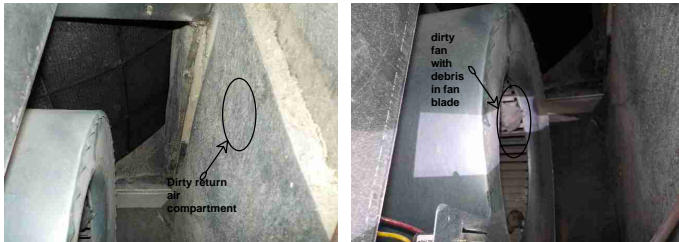
The return-air compartment is dirty. the evaporator coil and the ducts can become contaminated, and can be expensive to clean.

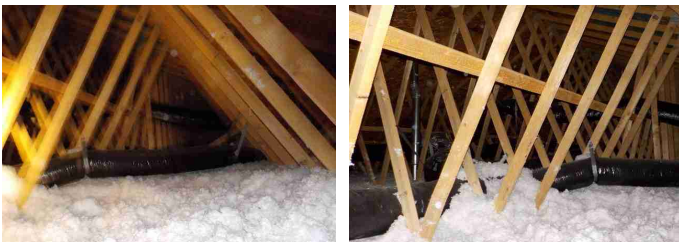
We have evaluated the attic in compliance with industry standards, and found it to be in acceptable condition.

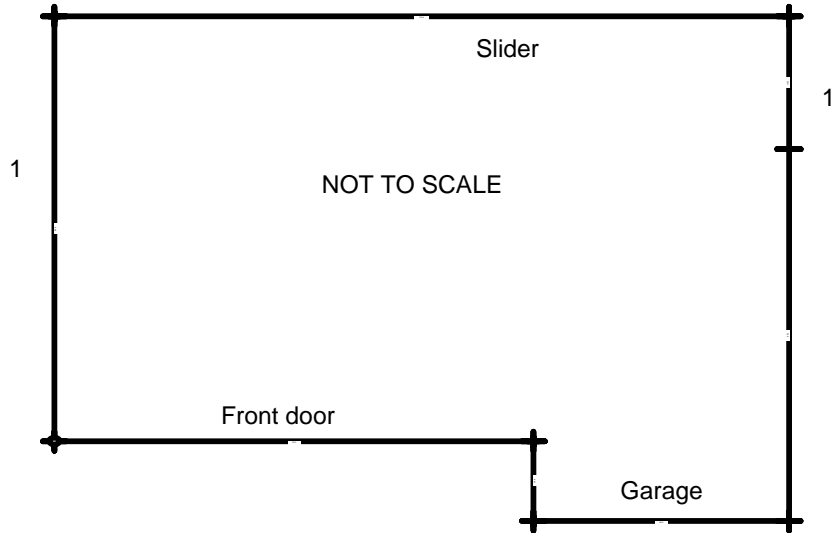
# PEST AND STRUCTURAL DRY ROT

There are areas of the siding that are damaged all damaged siding should be evaluated by a licensed contractor. (see PDR diagram for locations)
